NACA RM E51G13

RELATION OF ENGINE TURBINE-BLADE LIFE TO STRESS-RUPTURE
PROPERTIES OF THE ALLOYS, STELLITE 21, HASTELLOY B, CAST

S-816, FORGED S-816, X-40, NIMONIC 80, REFRACTALLOY 26,
N-155, AND INCONEL X

By F. B. Garrett and C. Yaker

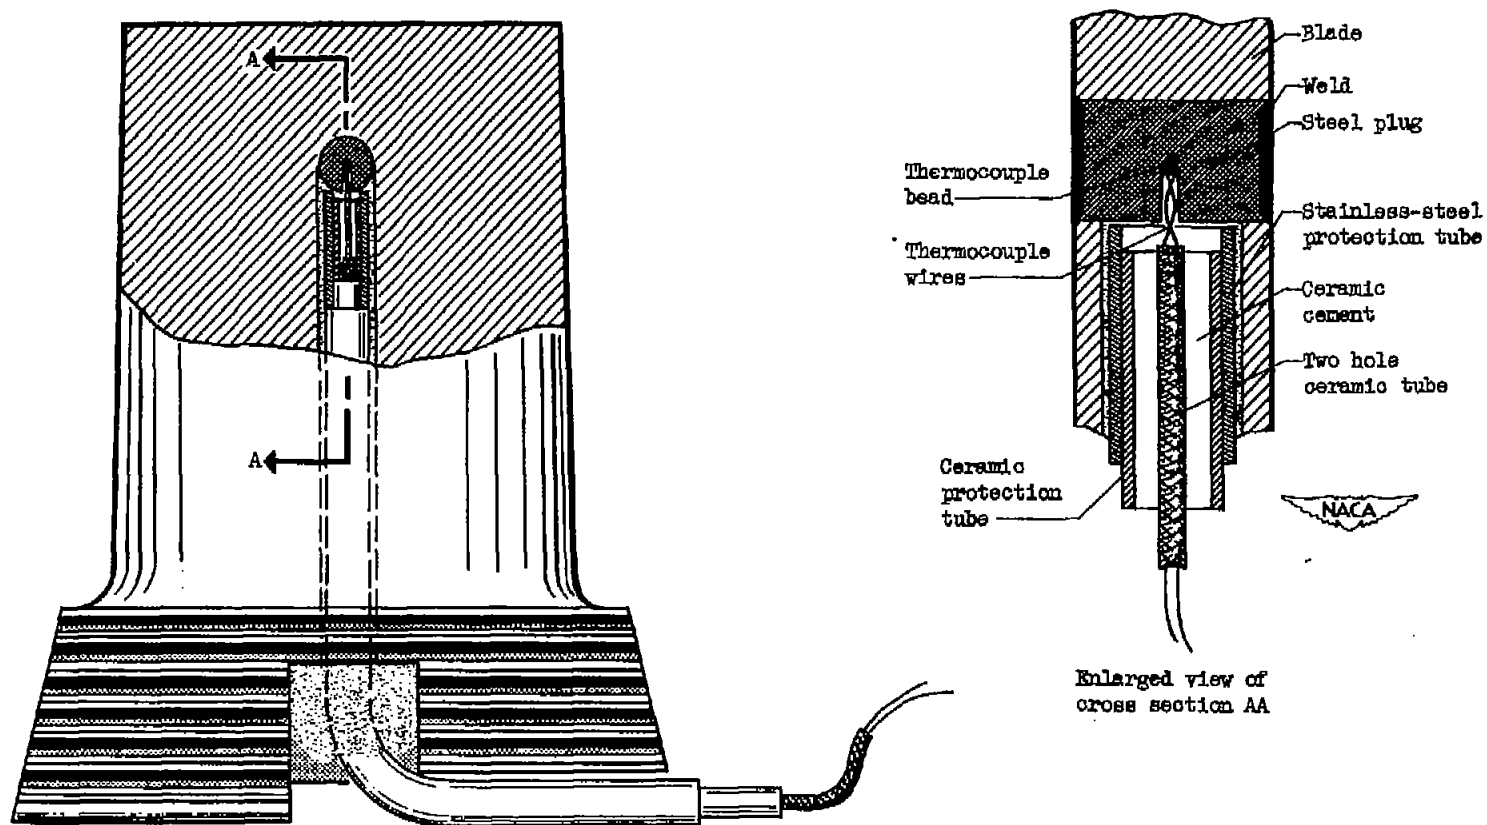
Figure 1. - Thermocouple installation in half blade.

Temperature control. - In order to make a reliable comparison of the results of engine operation and laboratory data, engine operating conditions had to be so regulated that the turbine blades were operating within a closely controlled range of centrifugal stress and temperature. Of these two variables, temperature is difficult to control, whereas stress is easily controlled by regulating engine speed. Earlier investigators of turbine-blade performance used the gas temperature as measured at the exhaust-cone outlet to control the experimental temperature (references 1 and 2). Changes in burner characteristics, blade twist, and atmospheric conditions during the run, however, would result in different blade temperatures at the same exhaust-cone gas temperature. More accurate blade-temperature regulation is achieved by a control based on the metal temperature itself. In order to control blade temperature during engine operation, thermocouples were therefore inserted in two blades in the rotor. The thermocouple electromotive force is measured

through a slip-ring pickup mounted on the front of the engine. The slip-ring pickup circuit for measuring the temperature is described in reference 3. In order to prevent failure of these blades because of the weakening effect of the hole drilled for the thermocouple, the airfoil section was reduced to one-half the original length to reduce centrifugal stresses in the weakened portion. The thermocouple mounted in the blade is shown in figure 1. The junction of the thermocouple is located 2 inches above the base of the half blades or at the midpoint of a full-length blade. This region is the zone of maximum blade temperature (reference 3). In order to relate the temperature of the half blade to the temperature of a full-length blade, a preliminary investigation was conducted in which temperature measurements were made 2 inches from the base of both half and full-length blades. The results of this survey indicated that at rated speed (11,500 rpm) the temperature of the full-length blade was approximately 25° F higher than that of the half blade.

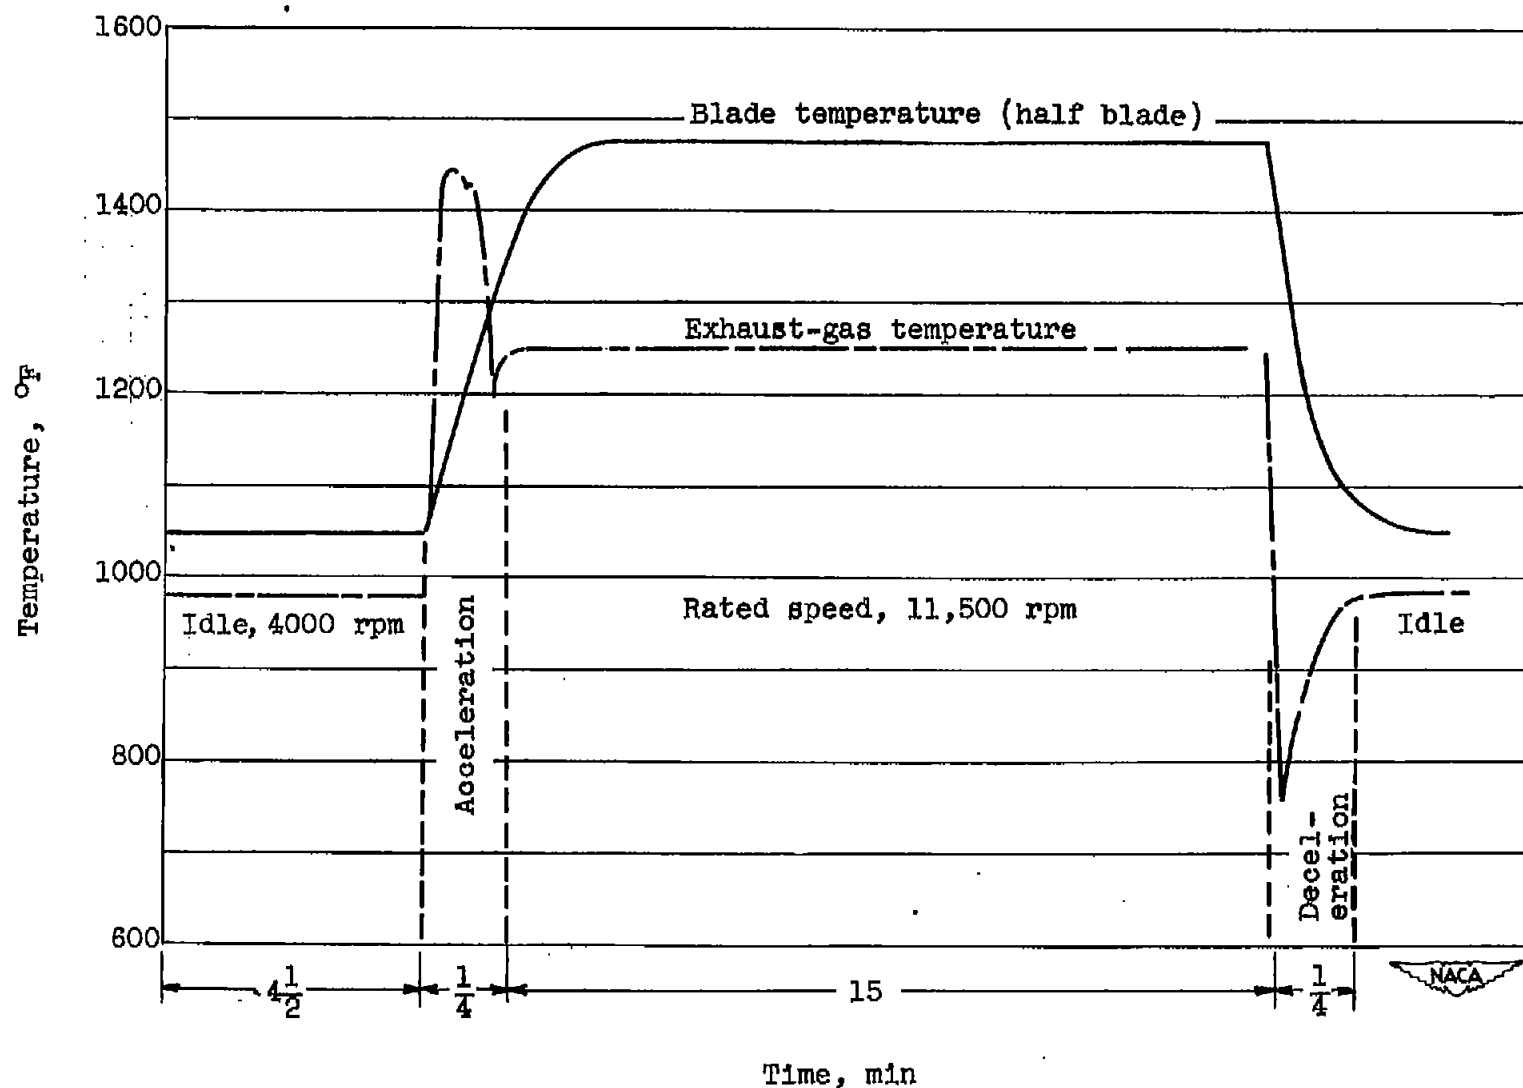
Figure 2. - Temperature conditions during typical engine cycle.

Engine operation. - The blades were operated in a J33-9 turbojet engine having a nominal thrust of 4000 pounds and employing a dual-entry centrifugal compressor. The engine has 14 combustion chambers. The engine, fuel, and instrumentation are described in reference 1. The engine investigation consisted of a repetition of the cycle shown in figure 2. During the rated-speed portion of the cycle, the gas temperature was varied to yield an indicated temperature of $1475^{\circ} \pm 5^{\circ}$ F 2 inches from the base of the half blade. Based on the preliminary investigation, this procedure would result in a temperature of $1500^{\circ} \pm 10^{\circ}$ F at the mid-point of a full-length blade. The blade temperature was read several times at the beginning of each day's operation to arrive at the proper gas temperature and then checked at regular intervals to assure the maintenance of the correct blade temperature. In figure 2, it is shown that the changes in exhaust-gas temperature during the acceleration and deceleration portions of the test cycle are not reflected in the blade temperature so that no overheating or subcooling of the blades occurs during these stages of the cycle.

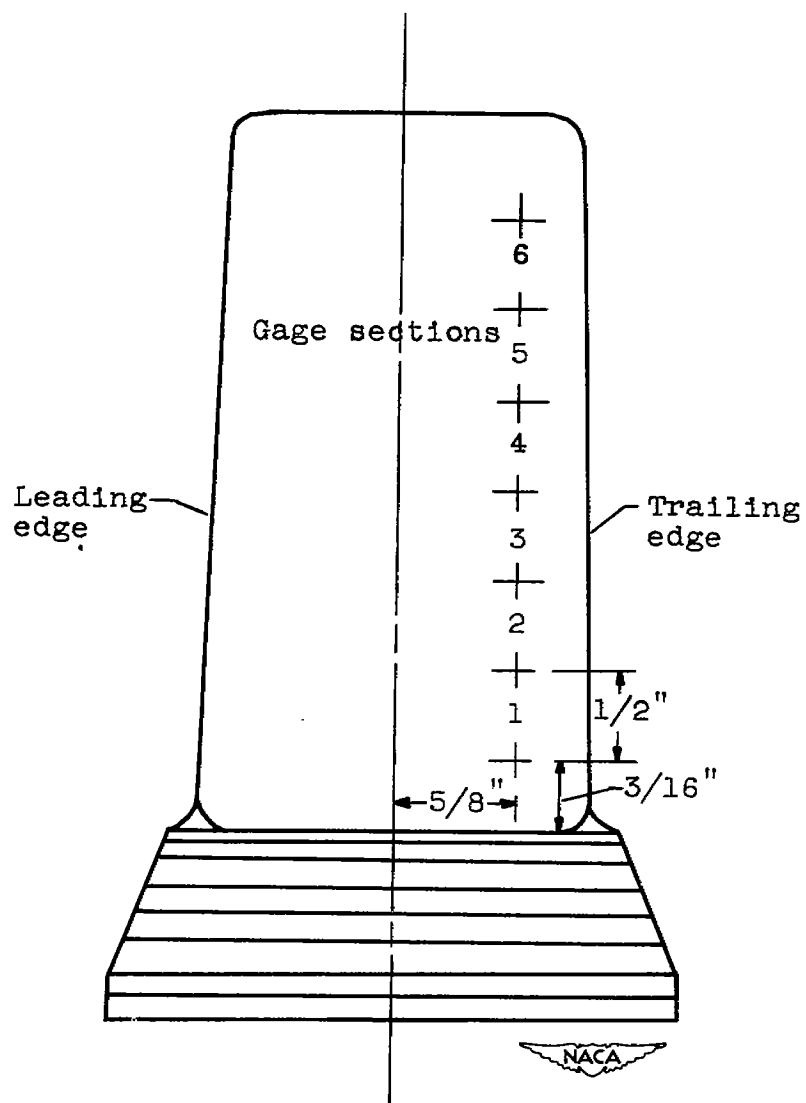
Figure 3. - Location of scribe marks on convex side of turbine blade for use in measuring elongation.

Three blades of each material were scribed in the manner shown in figure 3. At regular intervals during engine operation, measurements were made of blade creep between these scribed marks with an optical extensometer having a reading accuracy of ± 0.0001 inch. These creep measurements on the turbine blades were made after the blade was cold and the load removed in contrast with laboratory creep measurements, which are made under stress and at temperature. After a failure, the remaining blades were examined for damage resulting from failure of blades or of other engine components and the location and nature of the damage recorded. All blades were operated to failure, which is defined as either complete blade fracture or evidence of the beginning of fracture. In order to minimize the damage resulting from blade fracture, the thickness of the shroud in the engine tail cone surrounding the turbine rotor was reduced to allow blade fragments to pierce the shroud of the tail cone easily and to be thrown clear of the turbine.

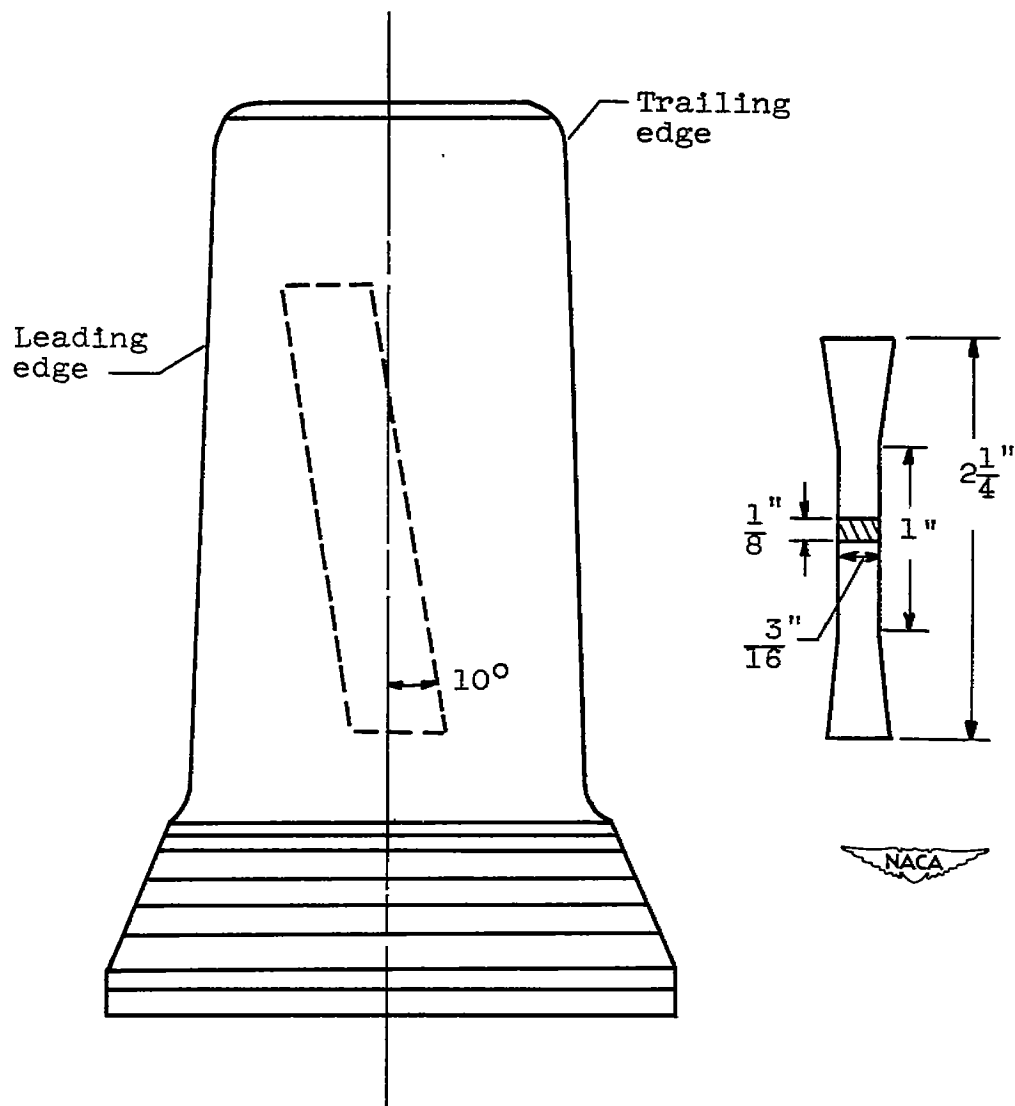
Figure 4. - Blade stress-rupture specimen and zone from which it was machined.

High-temperature strength evaluations. - Stress-rupture tests were conducted on specimens cut from the airfoil sections of blades from the same lots as those used in the engine operation. The shape of the specimen and the zone of the blade from which it was machined are shown in figure 4. The zone of the blade from which the specimen was cut was selected to give a maximum amount of material for a specimen the gage section of which is in the midzone (also the failure zone) of the airfoil section. The stress-rupture tests were all conducted at 1500° F in machines using a loading system, which consisted of a simple beam acting through a system of knife edges. The specimens were heated in a resistance-type furnace. The specimen temperature was so controlled that there was less than a 5° F variation along the length of the specimen with the average temperature varying only $\pm 2^\circ$ F.

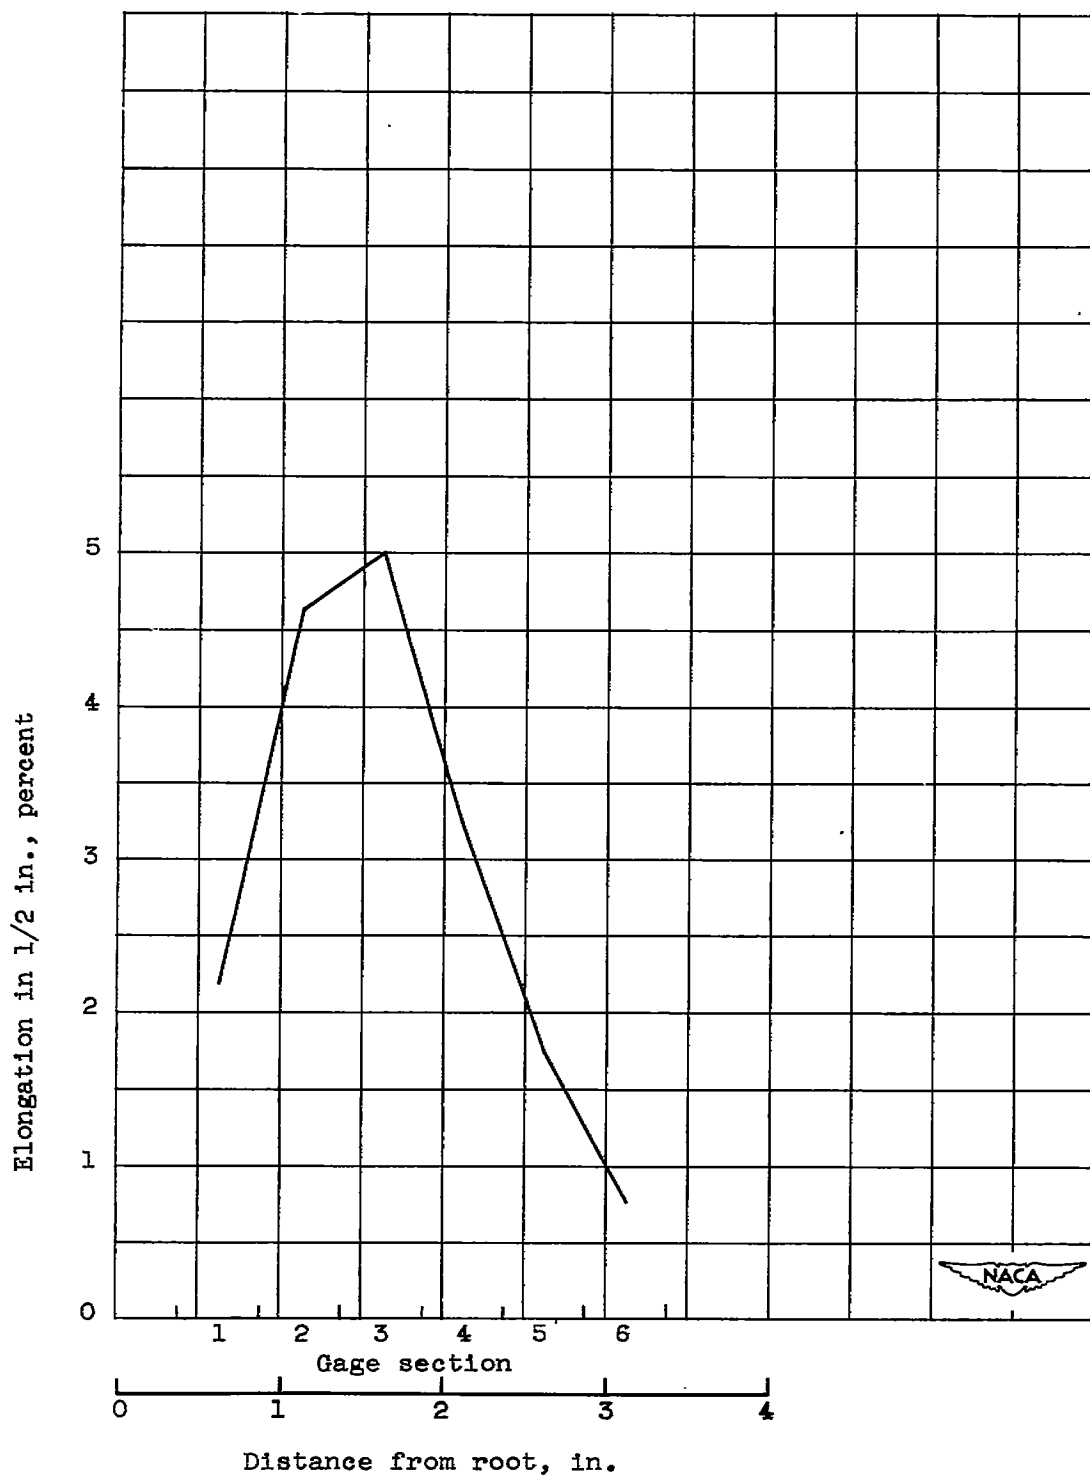
Figure 6. - Elongation distribution in Hastelloy B blade after 15 hours of operation.

The results of the blade-creep measurements indicate that the zone of maximum creep lay just above or below the middle of the blade airfoil section. The elongation distribution along a Hastelloy B blade typical of most of the alloys is shown in figure 6. For this blade, the maximum elongation occurred in section 3, which is just below the middle of the blade. In general, however, the section of maximum elongation was either 3 or 4, the sections just below or above the middle of the blades. In figure 7, the creep curves for sections 3 and 4 are plotted for all the scribed blades that had true failures (not the result of damage). The creep behavior of the alloys, Stellite 21, Hastelloy B, cast S-816, forged S-816, X-40, and N-155, can be considered normal as the curves are normal in shape. The alloys, Nimonic 80, Refractalloy 26, and Inconel X, did exhibit anomalous behaviors because for all three alloys negative values of creep were measured. The alloys, Refractalloy 26, and Inconel X, also showed a rapid increase in elongation sometime between 20 and 30 hours of operation. A possible explanation is that the unusual creep was the result of structural changes occurring in these alloys during engine operation. It may be significant that all three alloys are the so-called age-hardenable type containing titanium and will age at 1500° F. The alloys may age during engine operation by a reaction that results in negative creep. In the cases of Refractalloy 26 and Inconel X overaging may occur, which results in very rapid elongations until the structure stabilizes, possibly as a result of strain hardening. The possibility that the sudden stretch in the Refractalloy 26 and Inconel X blades was due to overtemperature during operation was discounted because the engine-operation data did not indicate any such conditions and the effect was not evident in other alloys. Some corroboration of the suggested cause of the anomalous creep behavior of these alloys may be found in the results of the metallurgical examination presented later.

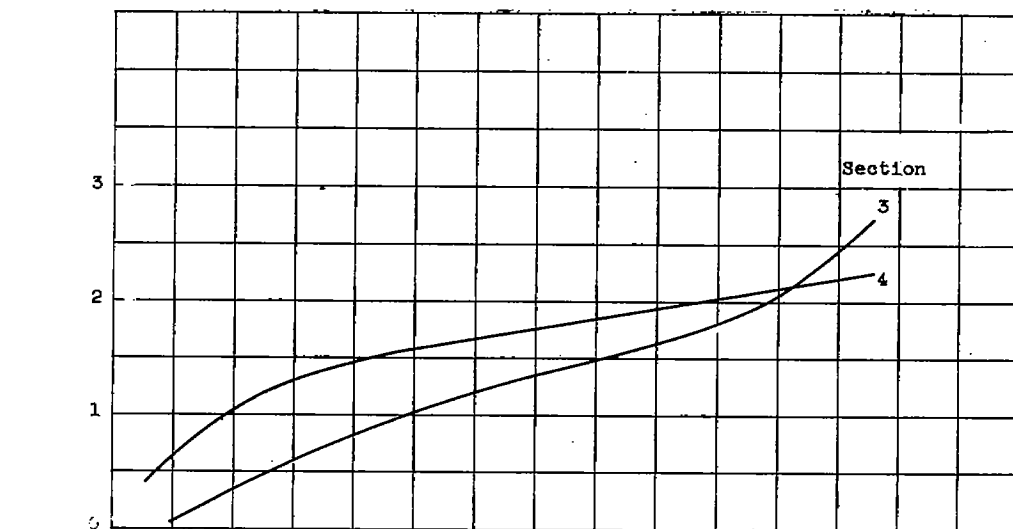
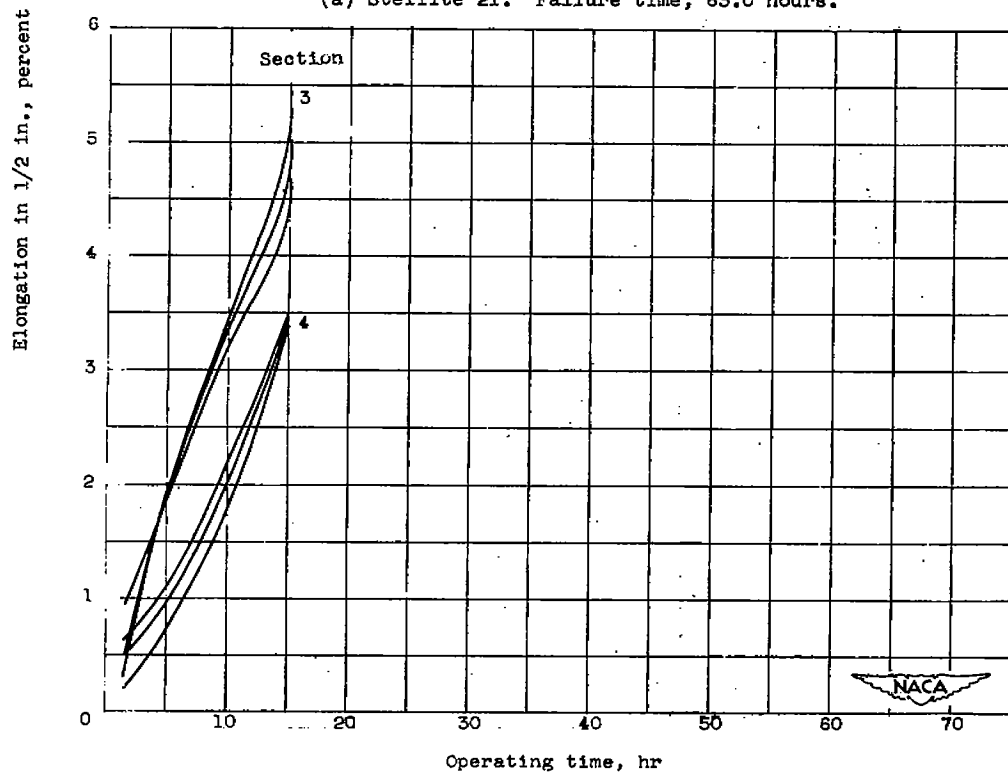
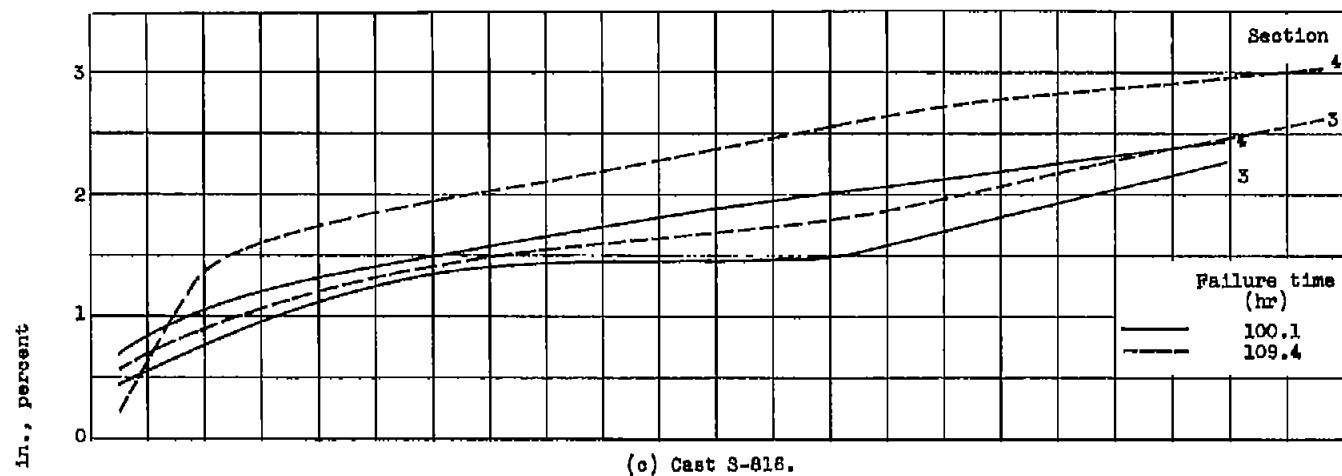
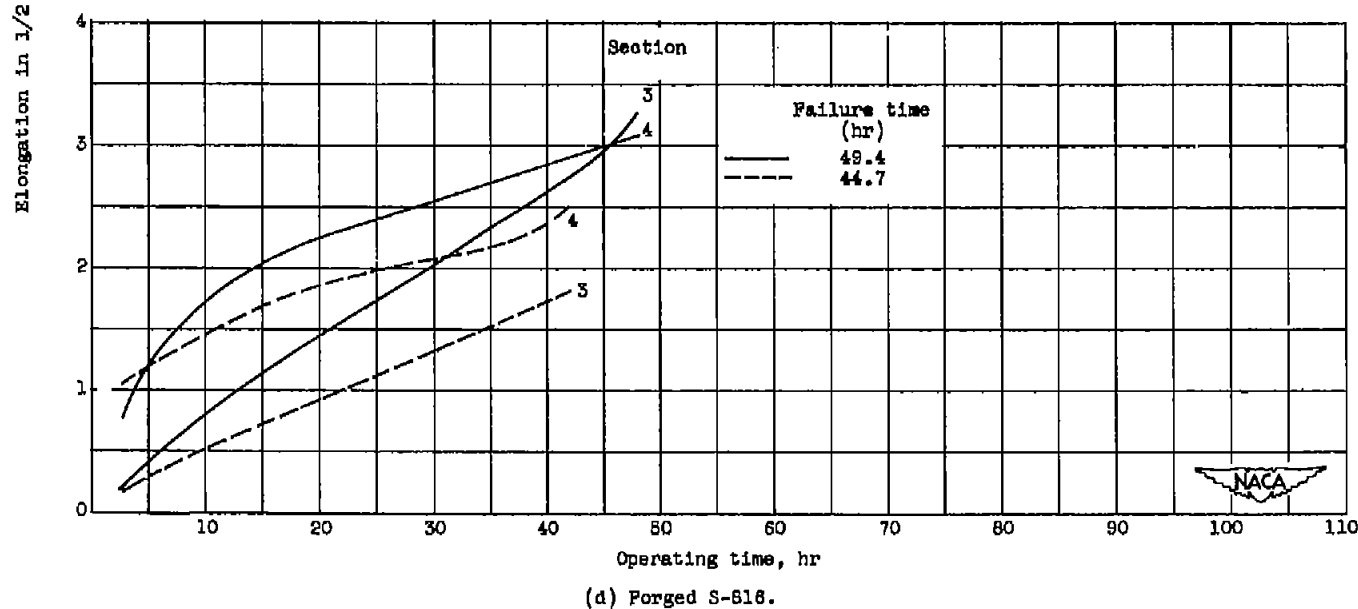
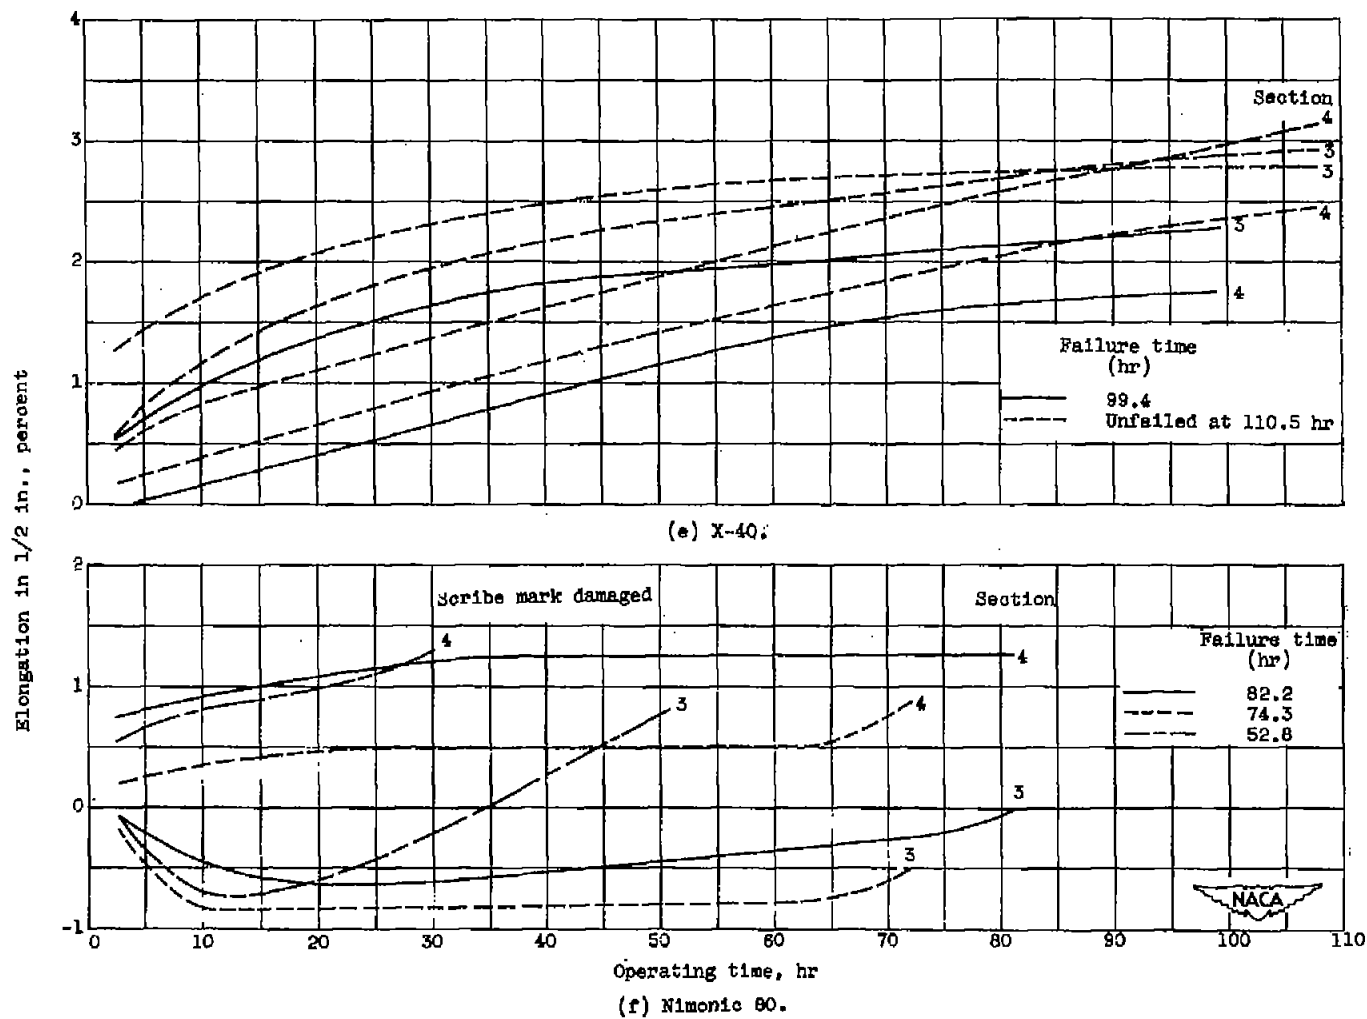
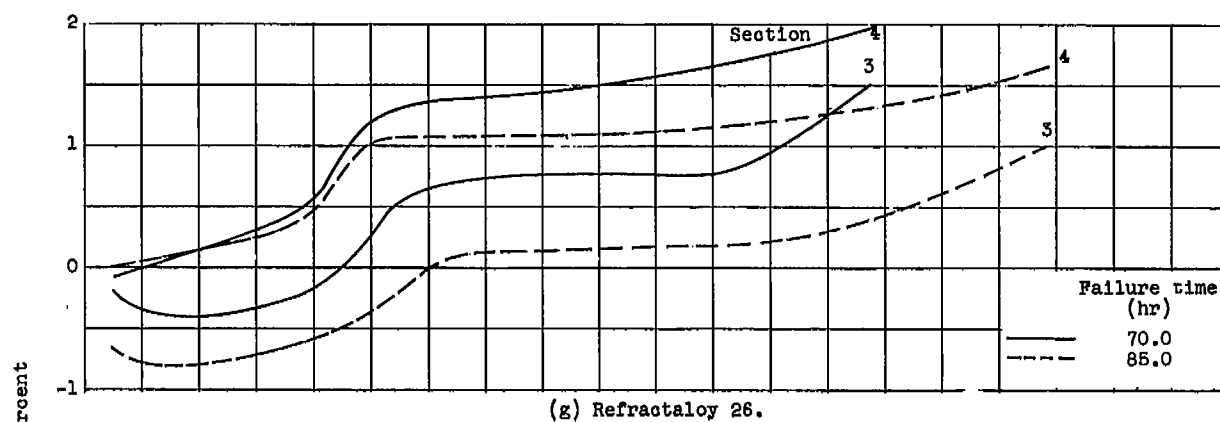
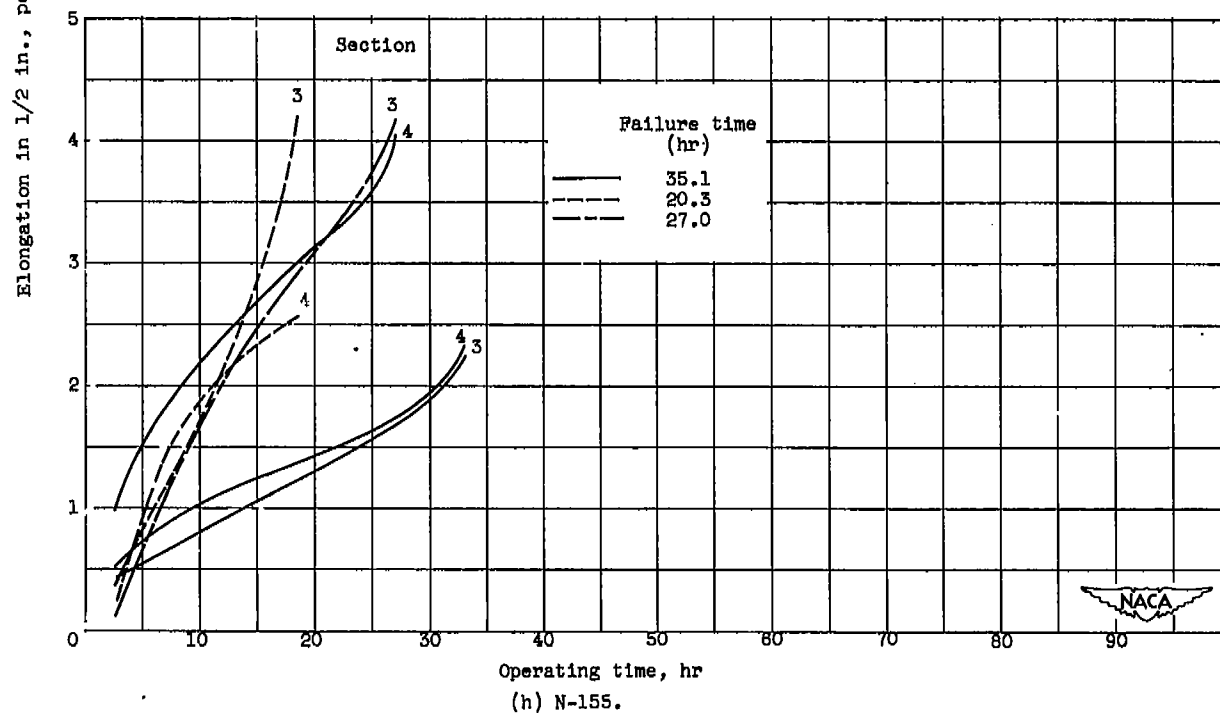
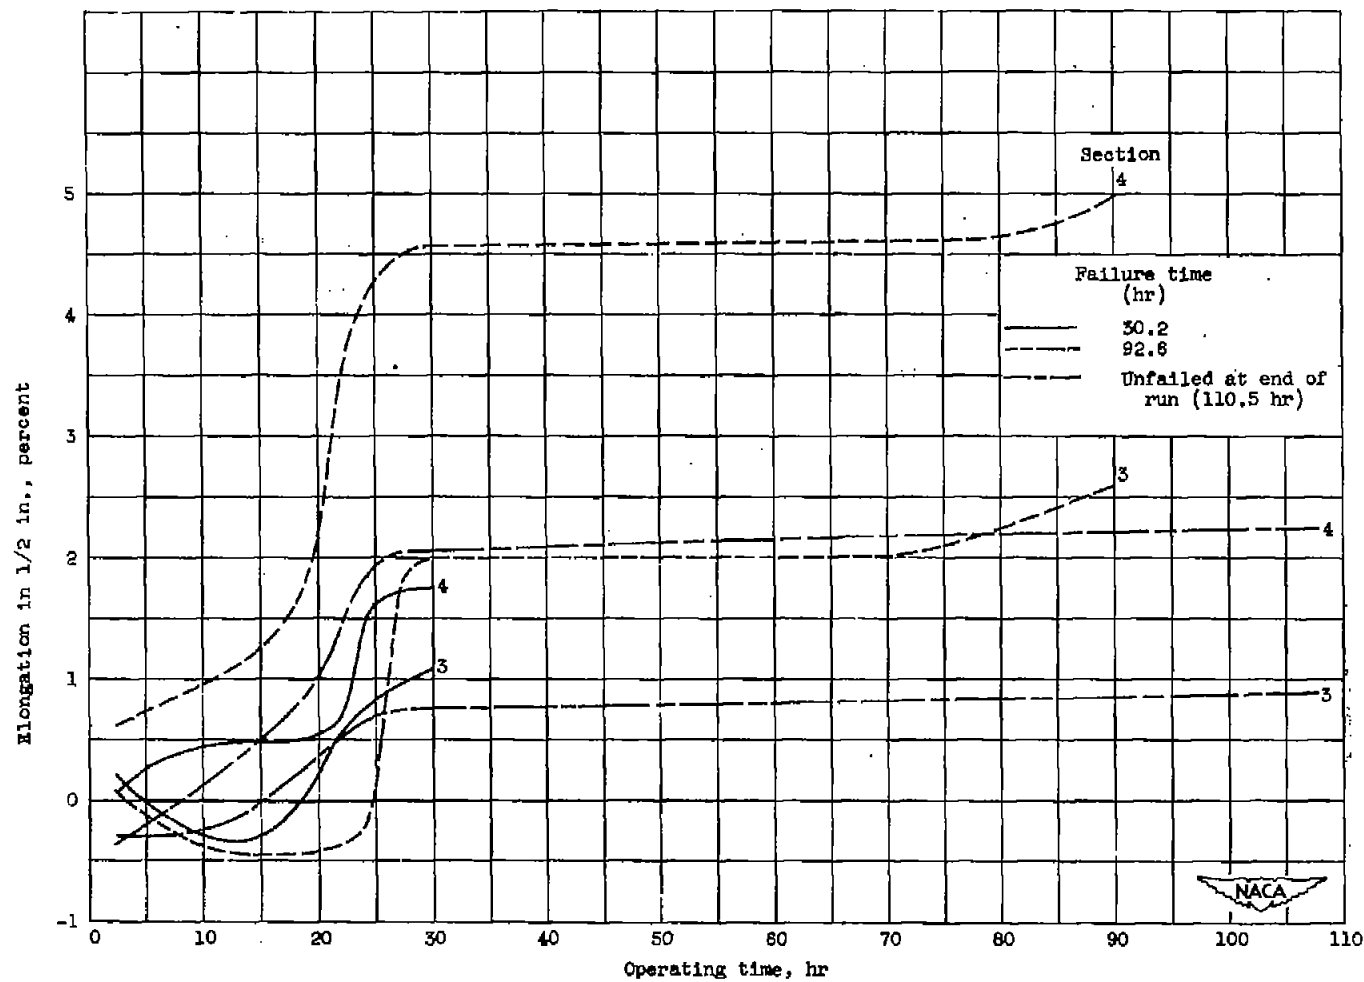
(a) Stellite 21. Failure time, 63.0 hours.

(b) Hastelloy B. Failure time, 15.0 hours.

Figure 7. - Creep curves during engine operation for blades that had true failures.

The final blade elongations in zones 3 and 4 prior to failure for true blade failures plotted in figure 7 are listed in table IV. The values given in table IV are those measured at the shutdown time just before failure. Because of the limited number of blades in each sample, no definite conclusion can be made about blade elongation as compared with blade life. One of the significant points in the curves is the

relatively short third-stage portion of the creep curve and in some cases the absence of all evidence of third-stage creep. The elongation at the point of initiation of third-stage creep appears to be the point of importance in blade creep because failure occurs shortly after the blades have stretched to this elongation.

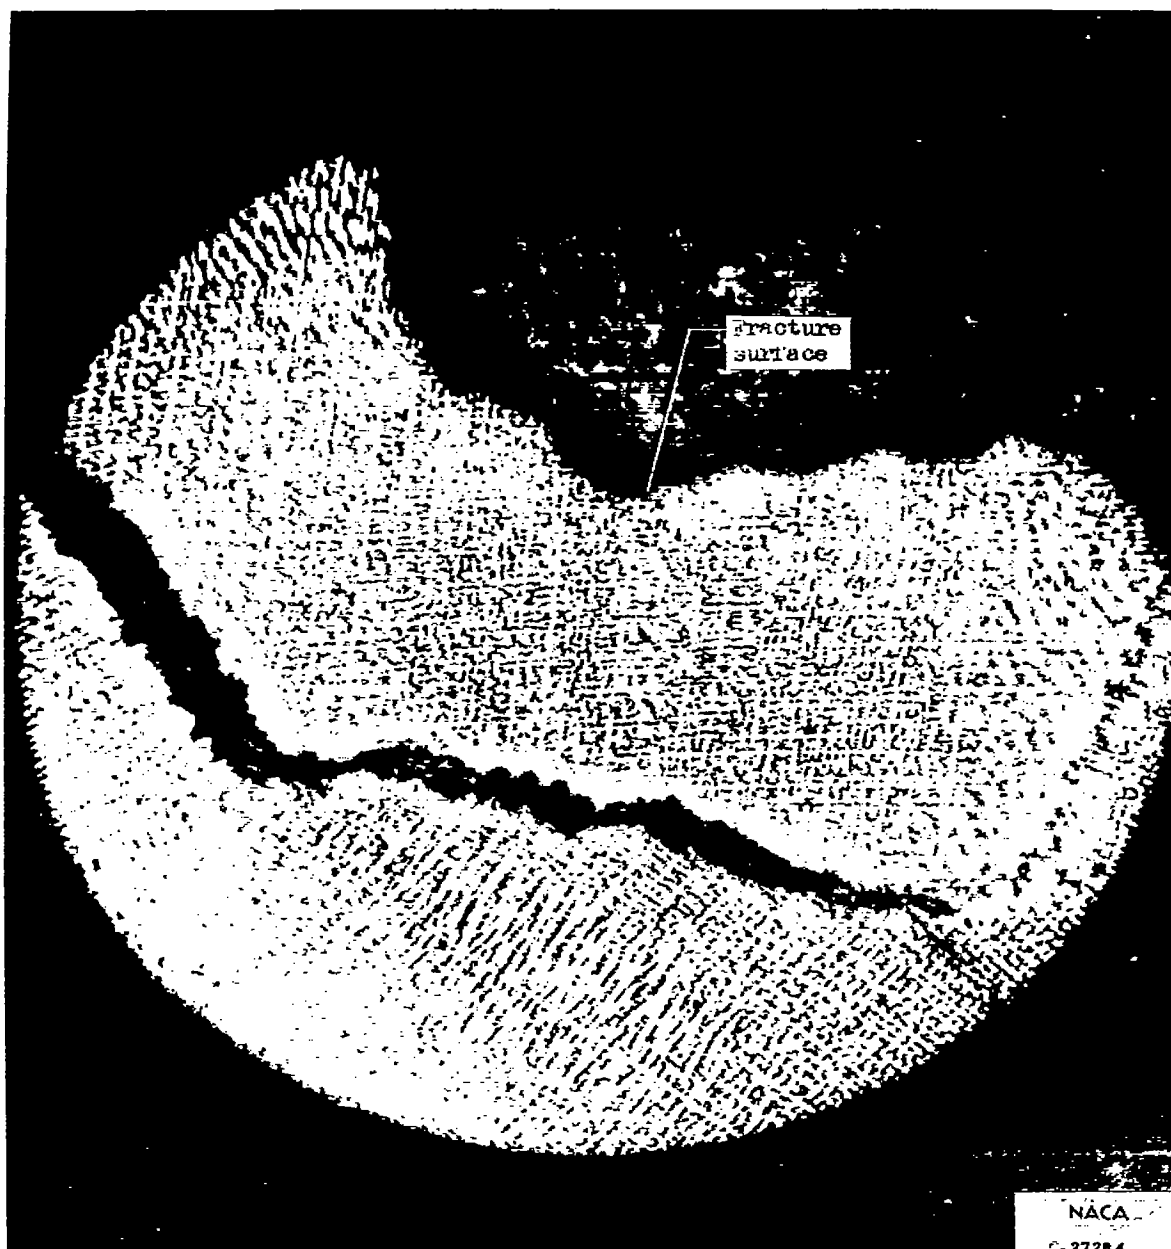
(a) Surface distraction and beginning of failure after 45 hours of operation.

Figure 8. - Results of metallurgical examination of Stellite 21 blade.

(b) Fractured blade after 46.2 hours of operation. Fracture is typical of sample failure.

(c) Intergranular fracture surface and crack. Electrolytically etched in 10-percent chromic acid. X50.

(d) Structure before operation. Electrolytically etched in 10-percent chromic acid. X250.

(e) Structure after operation. Electrolytically etched in 10-percent chromic acid. X250.

The results of the metallurgical examination are presented in figures 8 to 16, which present the nature of the blade failures on a macroscopic and microscopic scale, the changes in structure during operation, and for the forged alloys, the grain size of the blades. No metallurgical examination of the Hastelloy B blades is included in this report because the nature of the blade failures and structural changes are the same as those described in reference 5. In all cases the microphotographs shown are those believed typical of the entire blade sample both as to nature of failure and structure before and after operation. The results of the metallurgical examinations of the blade failures indicate that the failures were of the following three types:

(1) Failures in which the origin of the fracture is characterized by an irregular granular surface having no evidence of fatigue-type failure. The fracture has an intercrystalline path and small intercrystalline cracks are present in the area just below the failure zone. Because of the similarity of failures of this type to those encountered in laboratory stress-rupture investigations, these failures were classed as the stress-rupture type.

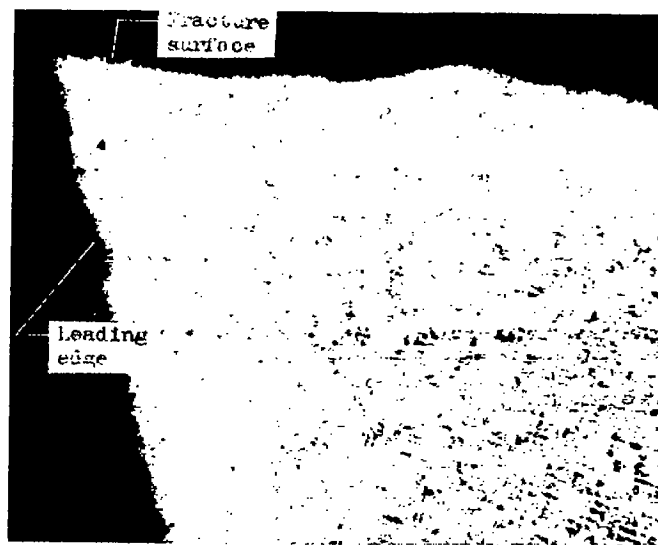
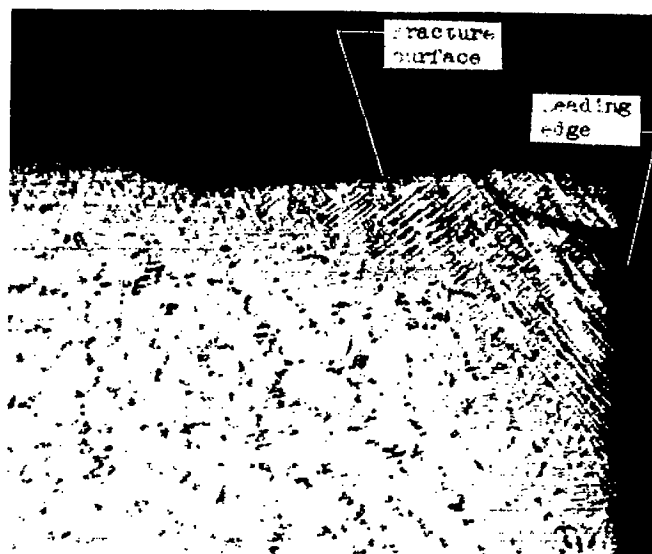
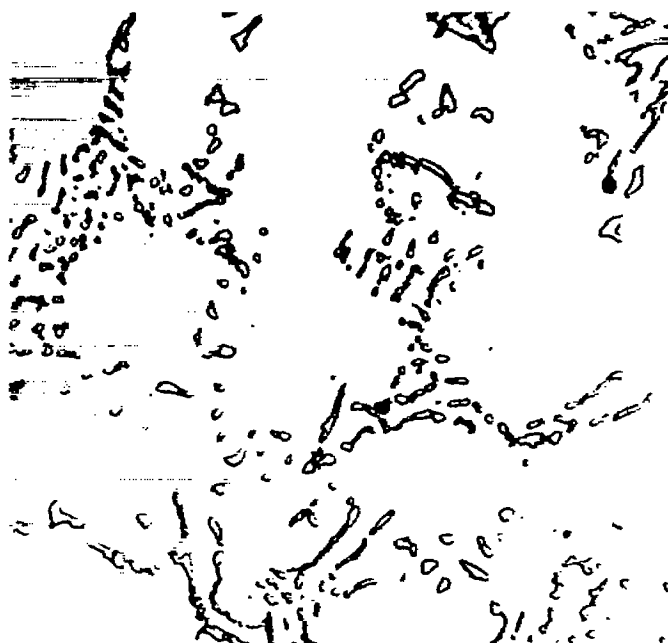
(a) Typical blade failure.

Figure 9. - Results of metallurgical examination of cast S-816.

(b) Transcrystalline fracture at leading edges. Electrolytically etched in 10-percent chromic acid; X50.

(c) Structure before operation. Electrolytically etched in 10-percent chromic acid, X1000.

(d) Structure after operation. Electrolytically etched in 10-percent chromic acid, X1000.

(2) Failures characterized by a smooth fracture surface at the failure origin sometimes showing the familiar concentric ring markings of a fatigue failure. These failures have a transcrystalline path. In this class, fall the failures that are the result of the combined effects of the centrifugal and vibratory stresses and show no evidence of initiation of the stress-rupture-type failure. These failures will be classed as the fatigue type.

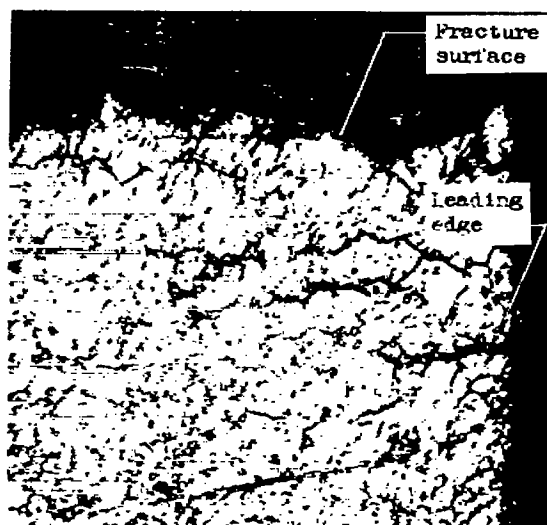
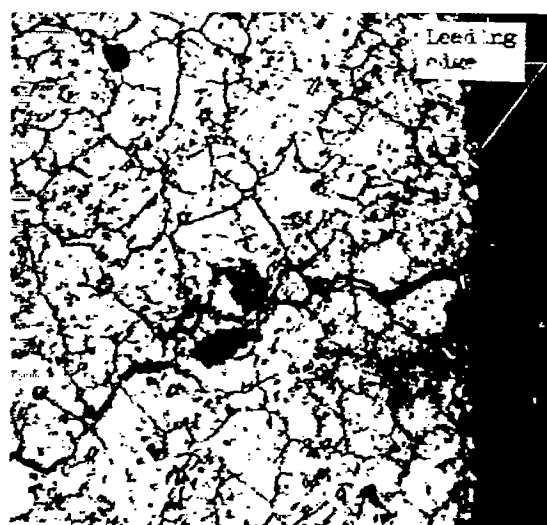
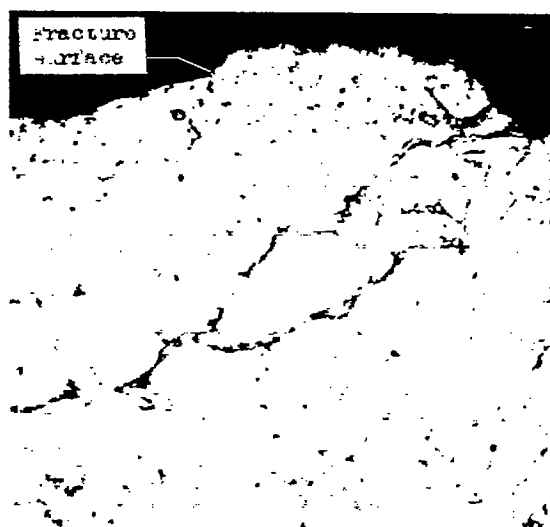
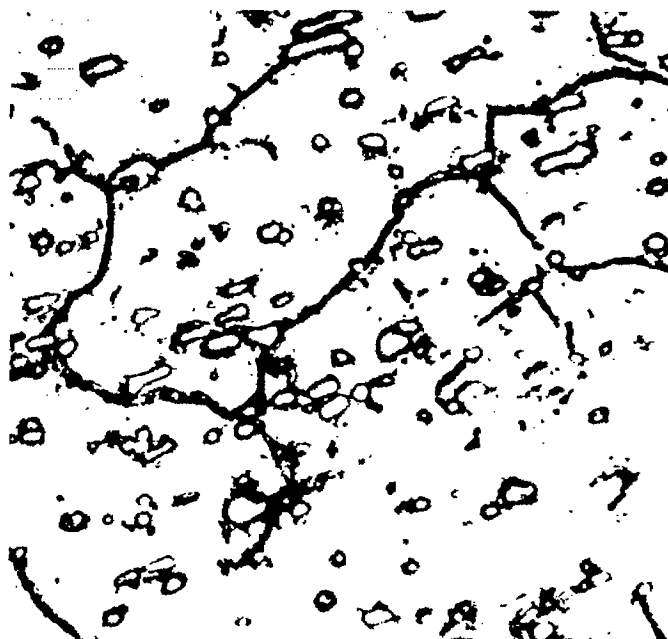
(a) Typical blade failure.

Center of blade, A.S.T.M. 4 to 6

Leading edge of blade (zone of failure
origin), A.S.T.M. 6 to 7

(b) Grain size. Electrolytically etched in 10-percent chromic acid, X100.

Figure 10. - Results of metallurgical examination of forged S-816 blade.

Intercrystalline cracking and fracture path at leading edge; X150.

Intercrystalline crack at leading edge; X250.

Transcrystalline fatigue fracture path nucleated by intercrystalline cracks; X250.

(c) Nature of fracture propagation. Electrolytically etched in 10-percent chromic acid.

(d) Structure before operation. Electrolytically etched in 10-percent chromic acid; X1000.

(e) Structure after operation. Electrolytically etched in 10-percent chromic acid; X1000.

(3) Failures in which the fracture was initiated in a zone similar to that described for the stress-rupture-type failure. The failure then progressed through a zone of the fatigue-type failure. The stress-rupture origin of these failures is determined by macroscopic and microscopic examination of both the initial cracks detected during operation and the final fracture. These failures will be classed as the stress-rupture-followed-by-fatigue type.

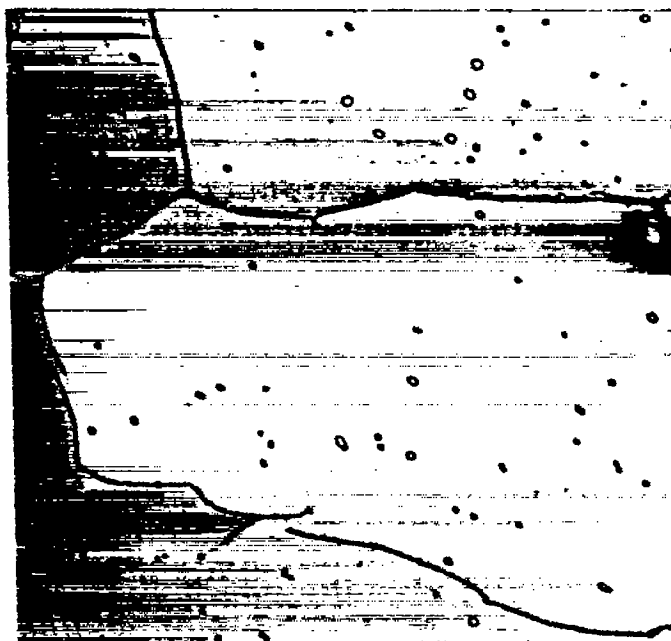
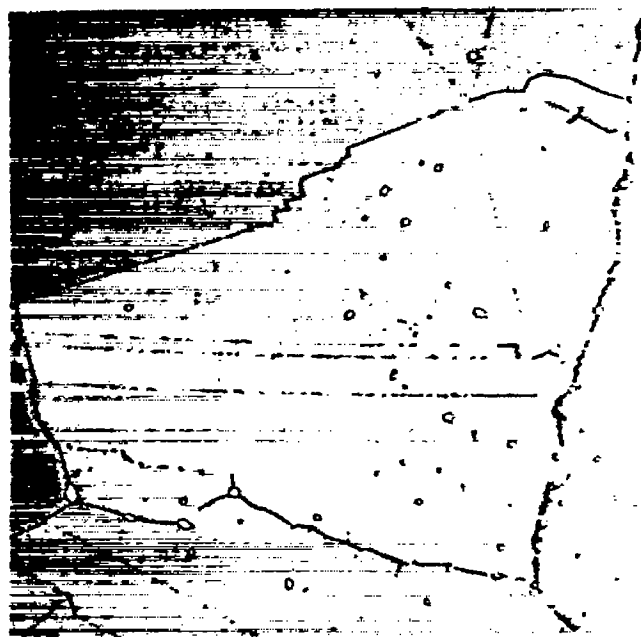
(a) Typical blades failure.

Figure 12. - Results of metallurgical examination of Nimonic 80 blades.

(b) Grain size throughout blade, A.S.T.M. 2 to 4. Electrolytically etched in 10-percent chromic acid; X100.

(c) Nature of fracture propagation. Electrolytically etched in 10-percent chromic acid; X150, oblique illumination.

(d) Structure before engine operation.
Electrolytically etched in 10-percent
chromic acid; X1000

(e) Structure after engine operation.
Electrolytically etched in 10-percent
chromic acid; X1000.
